Tips in solving clinical errors : Management of wire dislodgment

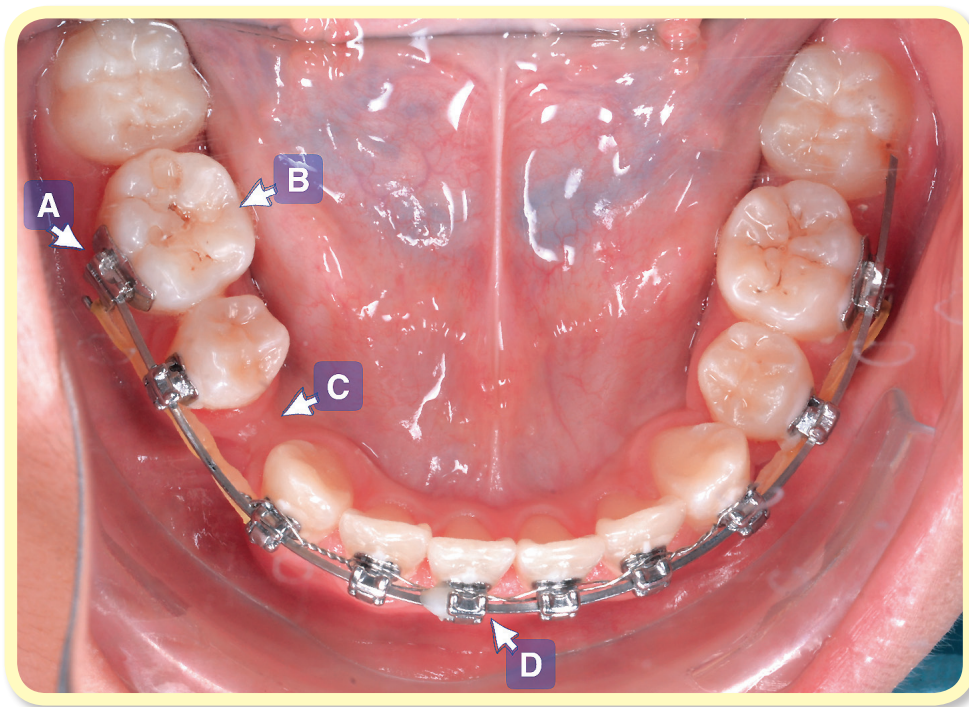
■ Fig. 1: Intra-oral photograph before adjustment.

The following is an example of how to apply this checklist to perform this assessment. Fig. 1 shows that the main archwire presents an excessive tail on the mandibular left side. One should first use an explorer to check if the opposite end of the archwire is fully engaged in the molar tube. When the tip of the explorer can enter the molar tube from the distal end, it is indicated that the wire is not fully engaged (Fig. 1A). Another indication of wire dislodgment is the counter-clockwise rotation of the molar (Figs. 1B & 2). Furthermore, a significant extraction space remains on the right side while the left one is closed. Such discrepancy is suspected to be caused by wire dislodgment, preventing the right molar tube from sliding along the archwire (Fig. 1C). Lastly, a resin stop on the left side is lost, which might contribute to the main archwire sliding (Fig. 1D).

With this list clinicians can easily and systematically analyze if the presence of an excessive tail should be cut flush or it is, in fact, a sign of wire dislodgment and should be re-engaged.

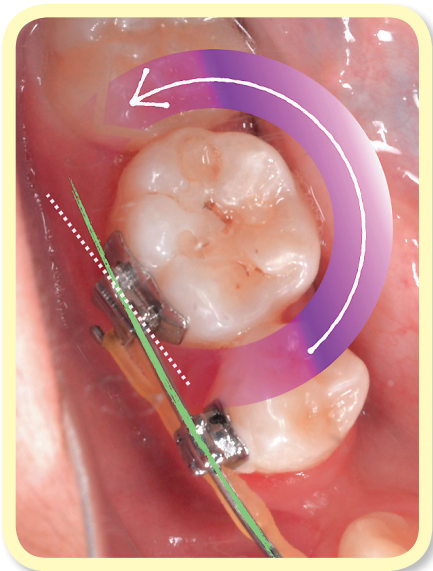
■ **Fig. 2:**
The relationship between long axis of the molar tube (purple dotted line) and the main archwire (green line) shows that the molar presents a counter-clockwise rotation.
